European Club of ICOLD
Working group on Levees and Flood Defences
EUCOLD LFD WG

Lessons learned from levee incidents and failures of German case studies

Working Group Meeting, 5th September 2023, Interlaken

M. Sc. Burcu Ersoy, M. Sc. Lucas Werner, Dr.-Ing. Ronald Haselsteiner

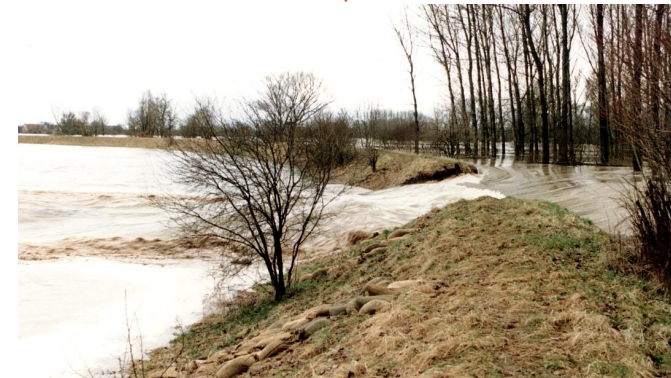
Elbe Flood 2013 – Levee failure near the village Fischbeck, Source: Jüpner (2016)

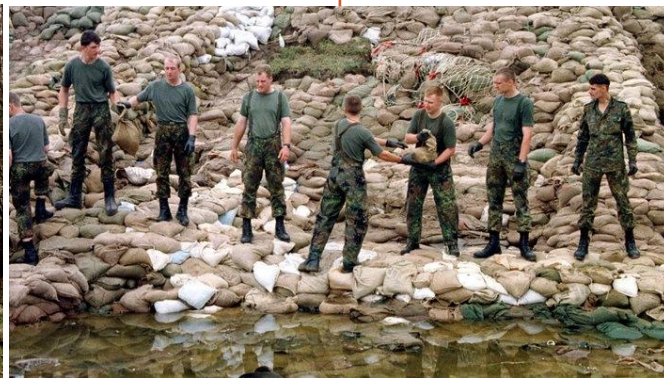
Levee failure nearby Stadldorf during Danube flood 1988 – initial breachign stage, Source: WWA Deggendorf

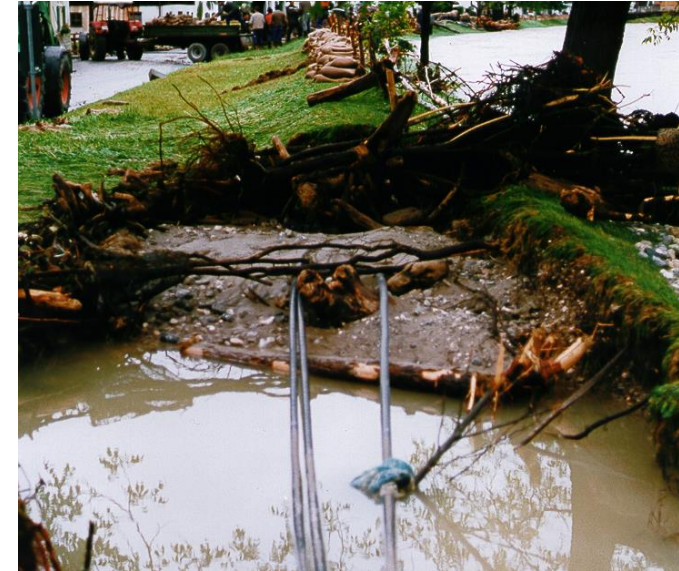
Levee failure on river Loisach (Loisach) after 1999 flood in Bavaria
(Source: WWA Weilheim)

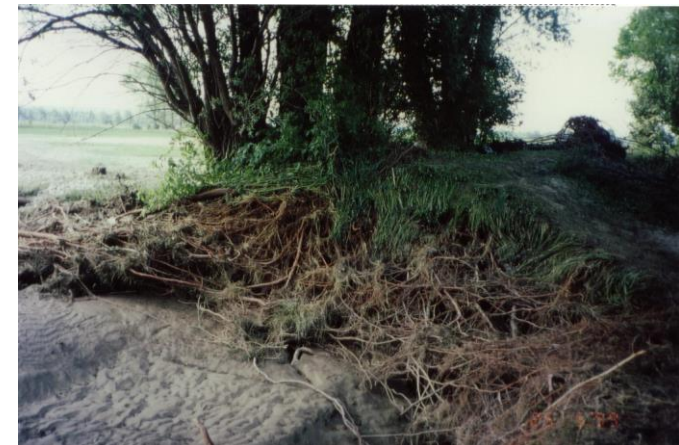
Levee failure on river Ammer after flood 1999 in Bavaria
(Source: WWA Weilheim)

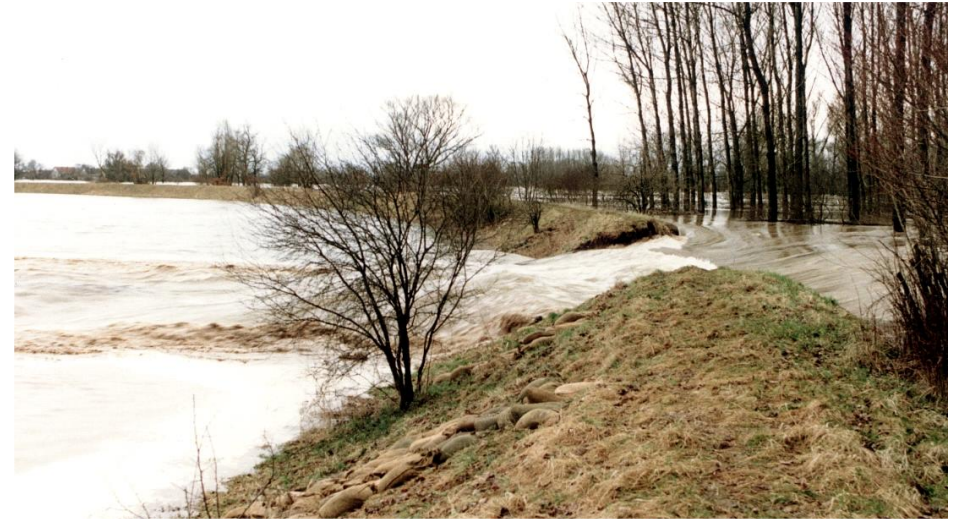
- Situation
 - During a medium flood incident in 1988 at the Danube River a levee failed
 - The levee was upgrading shortly before the flood incident
- Explanation
 - The downstream slope was enlarged by placing the same soil material as used for the overall existing main dam body
 - But, modern compaction works were applied in order to compact the soil layerwise so that the relative density was higher and the permeability was lower than in the main dam body
 - Pore water pressures developed so that a geotechnical slipping failure occurred
- Damage, deficits, threads, risks
 - Complete levee failure with flooding
 - Inadequate design and construction → inhomogeneous levee section

Levee failure at the village Stadldorf during the flood 1988 on the Danube-initial stage (Source: WWA Deggendorf)

- Lessons learned
 - Rehabilitation and upgrading of levees need to comply the same requirements than a new levee
 - A geotechnical expert need to be consulted; it is not mandatory in all federal states of Germany
 - Read and understand the available codes, regulations and bulletins

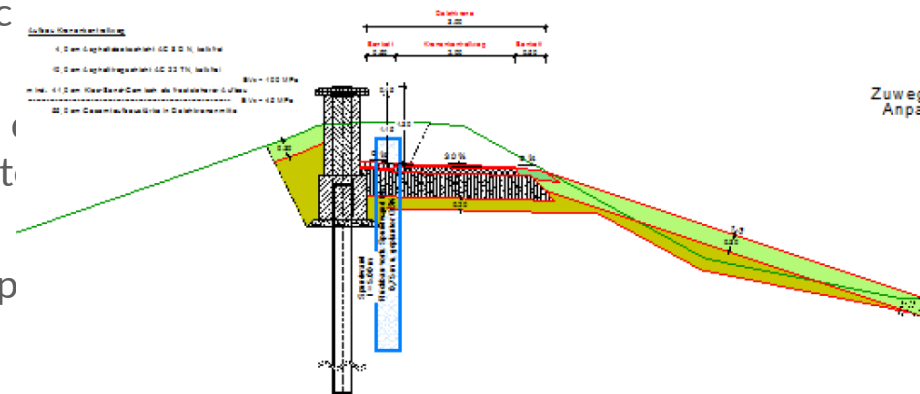
- After the 1997 flooding on the Oder river ad-hoc stabilization measures were carried out
- A steel sheet pile was placed in the center of the dike body integrated only in the flood loam layer (limited depth)
- After placing the sheet pile an crest road with asphalt pavement was carried out

- The dike body showed a low density, after further floods the deformations resulted in cracks and major deformations of the crest
- The design does not comply to techn. requirements

Rehabilitated levee section with old short sheet pile
(Source: LHW Magdeburg)

- Short-termed ad-hoc measures should be always rechecked after implementation
- A combination of ad-hoc and long-term measures should be adapted
- Read and understand the available codes, regulations and bulletins

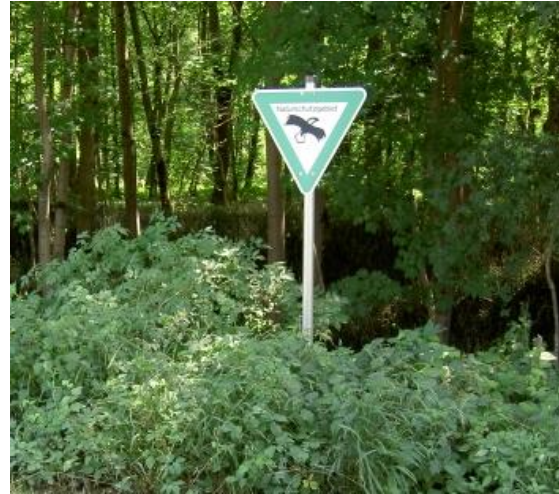
- Situation
 - Due to lack of floods also maintenance was lacking over years also due to poor financial resources
 - Many levee areas „vanished“ in upcoming forests
- Explanation
 - Before the 1980s serious floods were not occurring for decades
 - The importance of flood protection works was ranked subordinatedly
 - After decades those forests became nature protection areas
- Damage, deficits, threads, risks
 - All deficits and risks with large trees regarding stability, supervision and maintenance
 - Realization of flood protection or levee rehabilitation project difficult if special nature protection zones or protected species are present

Wooded levee at the River Danube nearby
(Source: StUGV)

- Lessons learned
 - Levees are technical flood protection structure which require strict supervision and maintenance
 - Forests and large trees contradict all requirements of a flood protection structure
 - Read and understand the available codes, regulations and bulletins

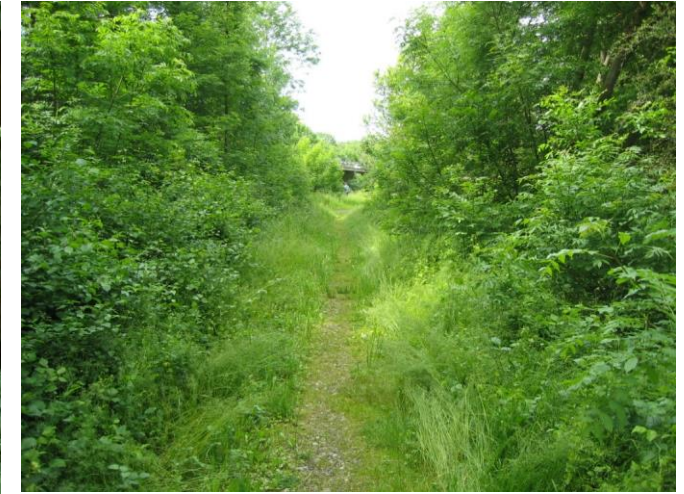
Wooded levee at the River Iller nearby
Altenstadt (Source: TUM)

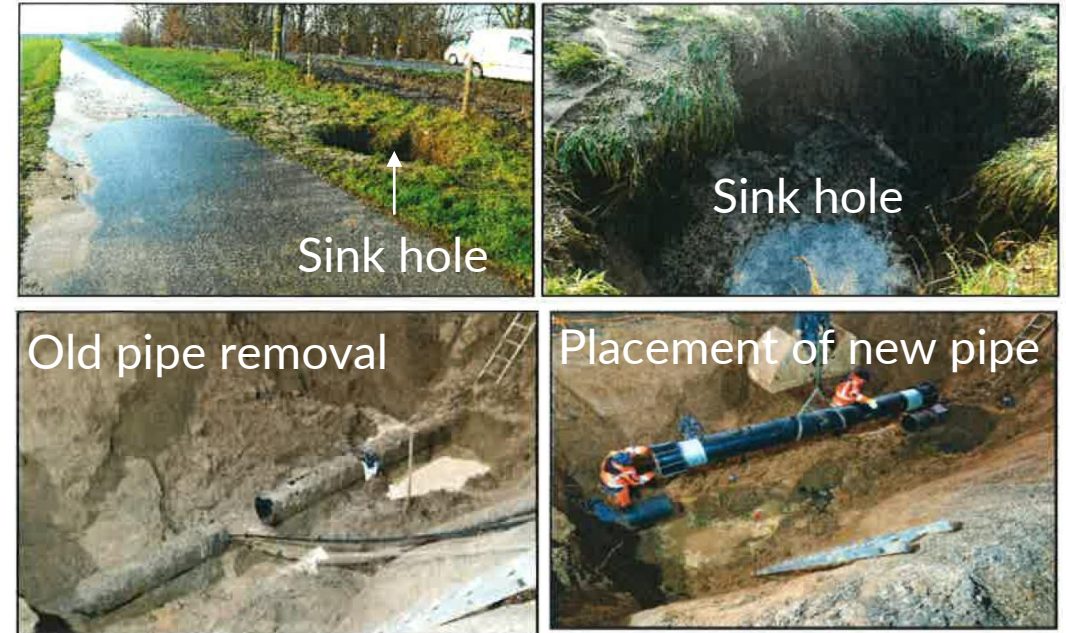
- Situation
 - In January 2023 a sink hole occurred within a dike at the Lower Rhine which was constructed some years ago
 - The sink hole developed over night and ad-hoc safety measures were initiated
- Explanation
 - A wastewater pressure pipe leaked and transported soil material from the underground so that a sink hole occurred on the surface
 - The operation of the pumping station was stopped and within a few days the pipe section was replaced and the construction pit was refilled
- Damage, deficits, threads, risks
 - The pipe is located under or near the Rhine levee which does not comply to regulations
 - No protection pipe was applied → The pipe failure caused critical erosion
 - The refilling of the pit was not done according to regulations

- Lessons learned
 - For new levees also old existing structures should be adapted, or as here shifted and replaced
 - A adequate emergency action plan should be available which also dictates the integration of expert knowledge in emergency situations
 - Read and understand the available codes, regulations and bulletins → Clear regulations for refilling were not given

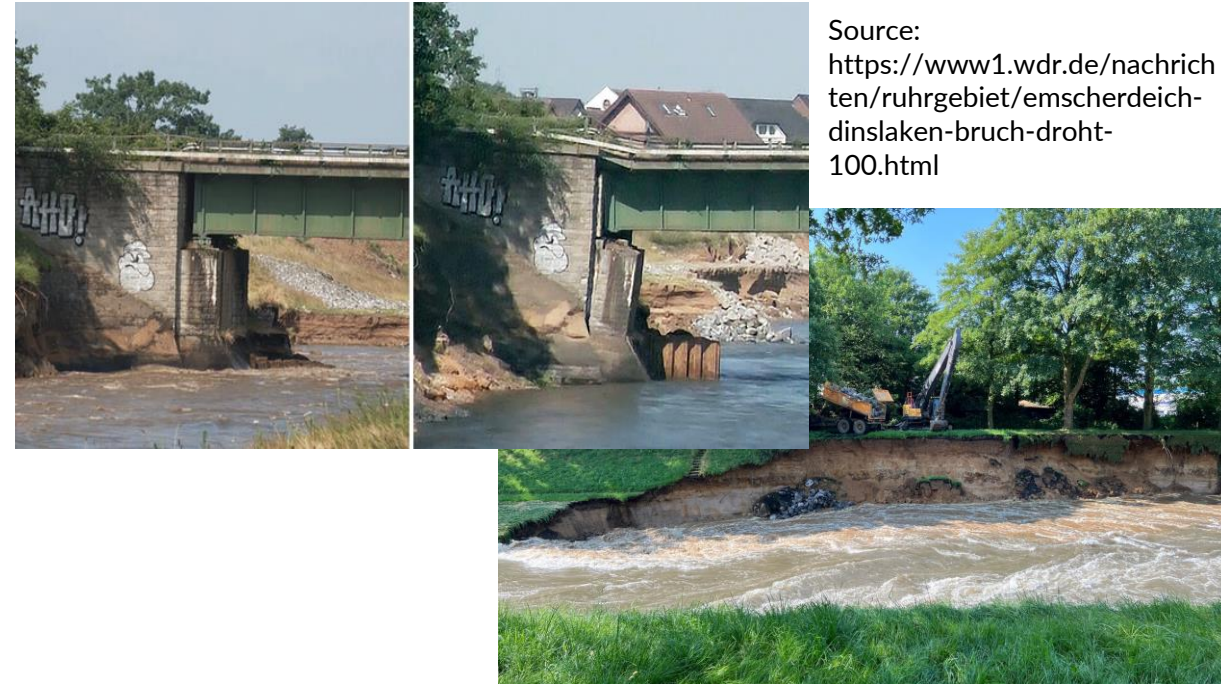
- During a medium flood incident in June 2023 a scour occurred a railway bridge of the Emscher River
- The bridge suffered serious deformation
- The adjacent levee suffered considerable erosion of the upstream slope

- Flow concentration at a bridge section of the Emscher River resulted in high velocities and scouring
- The scouring/erosion impacted a few hundred meters of the levee
- A complete failure did not occur thanks to the short flood period

- Complete erosion of the upstream levee body
- The risk of breaching was critical

- Special structures within a levee always represent a risk
- Damages on these structures may extend to the levee
- Structures within a levee/river should consider flood protection safety level
- Read and understand the available codes, regulations and bulletins
