European Club of ICOLD – Working Group on Levees and Flood Defences

The Ahrtal Flood in 2021

R. Haselsteiner, B. Ersoy, L. Werner

M&P Water, Koblenz, Germany

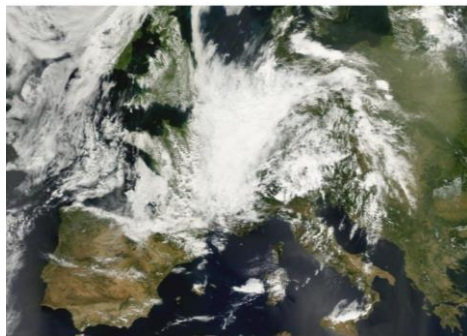
Picture 1: Low-pressure front „Bernd“ over Europe (Source: CEDIM, 2021)

In 2021 a devastating flood struck Europe. During 13th and 15th July 2021 a low-pressure front named “Bernd” (picture 1) moved relatively slowly across France, via Belgium through Germany to East Europe. In France, Belgium and Germany major floods resulted from the occurring heavy precipitation. The floods developed fast, thus, those floods could be defined as “flash floods” (Dallmeier, 2017) for which the development period is less than 24 hours. In Germany 188 fatalities are documented of which 135 were in the county of Ahrweiler where the river Ahr is located. The financial damage announced by the insurer Münchner Rück reached 46 billion Euro in total and, exclusively, 33 billion Euro in Germany and was, by these numbers, the second biggest natural disaster ever regarding insurance damage (see also picture 2).

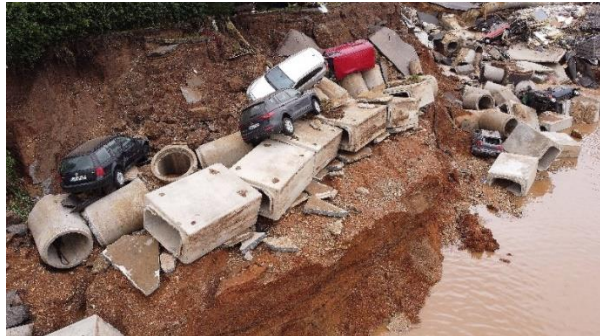
Picture 2: Flood damage in Erfstadt Blessem (Source: <https://rp-online.de/>)

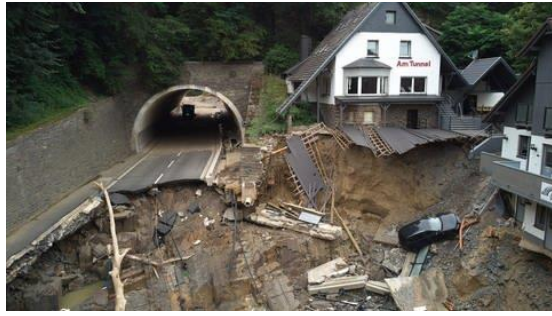
The flood caused harm on houses and infrastructure for which the reconstruction will take extraordinary investments and time (pictures 3 and 4). The discharge capacity of the flow section/riverbed was insufficient, erosion of the riverbed and banks as well as adjacent slopes caused slope failures, etc. Houses were flooded and flow velocity and forces resulted in many houses collapsing. The reconstruction of the roads, bridges and railways will take years and decades.

Picture 3: Damages on houses and infrastructure close to the villages Altenahr (Source: www.swr.de)

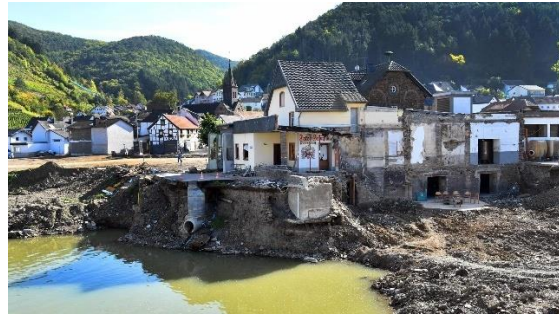
Picture 4: Erosion and destruction of houses in the village Dernau (Source: www.deutschlandfunkkultur.de)

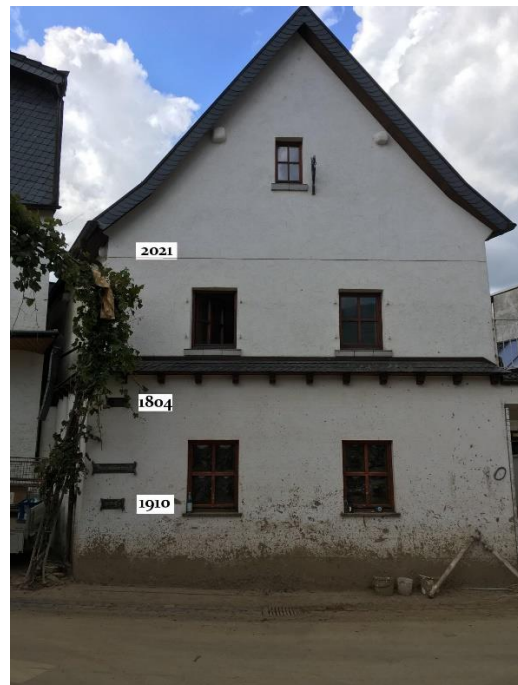
Natural hazards such as floods are not the primary cause for fatalities or damage. The primary cause is the infrastructural and urban developments which increases the vulnerability of affected areas, critically. This fact is documented by flood marks at a house in the village Dernau where the water level reached the first floor during the flood event 2021 (picture 5).

The house was already existing in 1804 but the flood level was much lower in spite of similar discharges. In the year 2016 the flood did only exceed the pavement elevation in front of the house and affected the basement which also led to the fact that many inhabitants made a critical underestimation of the imminent flood risk during the 2021 floods

Picture 5: Flood marks at a house in the village Dernau (Source: Mr. Matthias Habel, see also Roggenkamp, 2021)
