**ICOLD-CIGB 2019 SYMPOSIUM:  
SUSTAINABLE AND SAFE DAMS AROUND THE WORLD  
UN MONDE DE BARRAGES DURABLES ET SÉCURITAIRES**

## Woody vegetation on levees in Germany – Requirements, technical solutions and case studies

Dr.-Ing. Ronald Haselsteiner (Bjoernsen Consulting Engineers)

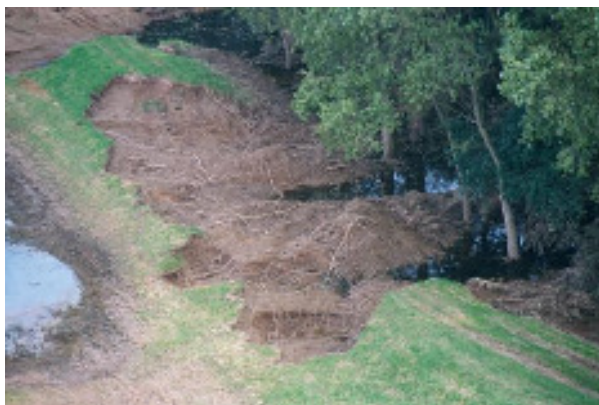
Dike breach during flood incident 1999 at the river Ammer  
(Source: WWA Weilheim)

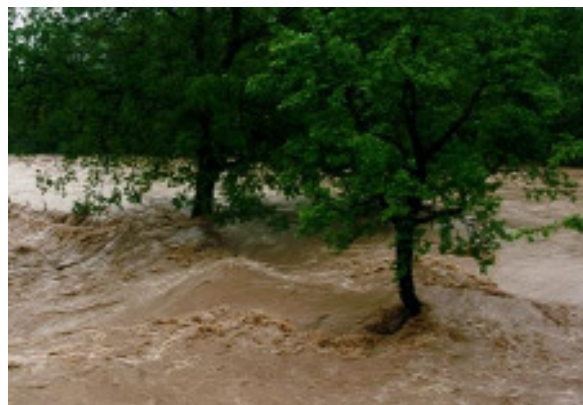
Dike break in Eschenlohe (1999)  
(Source: WWA Weilheim)

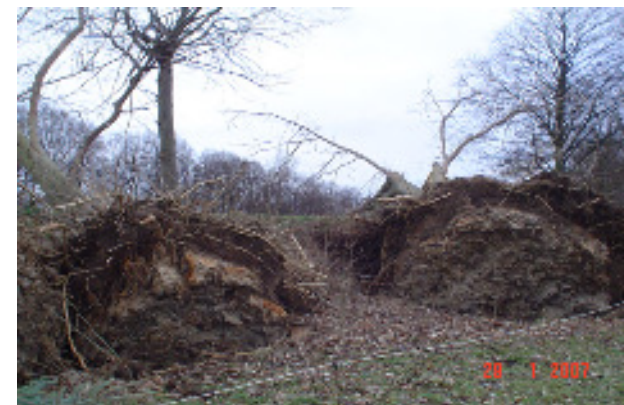
Windthrow at dikes at the Black Magpie during storm Kyrill 2007  
(Source: LUA Brandenburg)

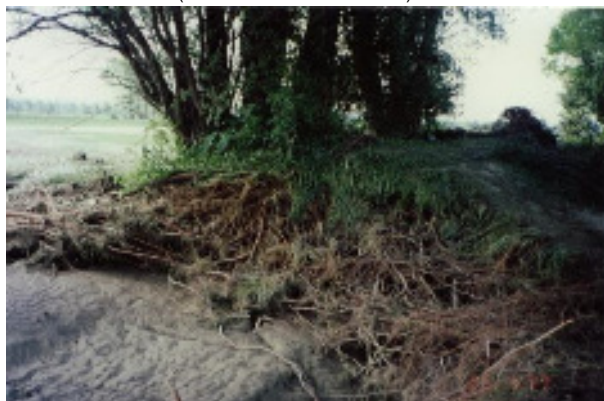
Failed Dike at River Mulde (2002)  
(Source: Landestalsperren-verwaltung Sachsen)

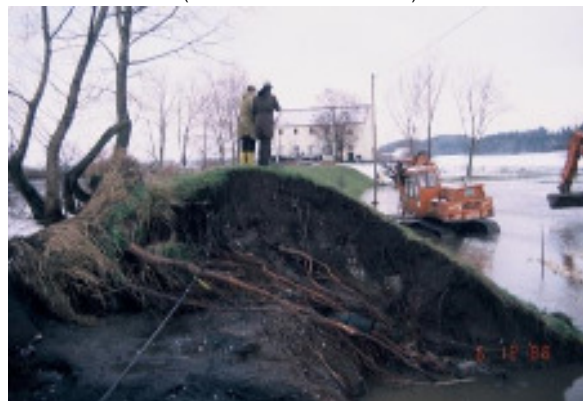
Dike breach during flood incident 1988 at Höselhurst  
in Danube (Source: TUM)

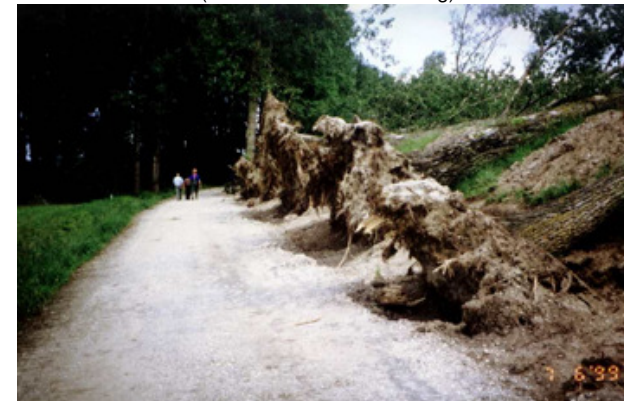
Tree failure at a dike in Germany 1999  
(Source: StMUVG NRW)

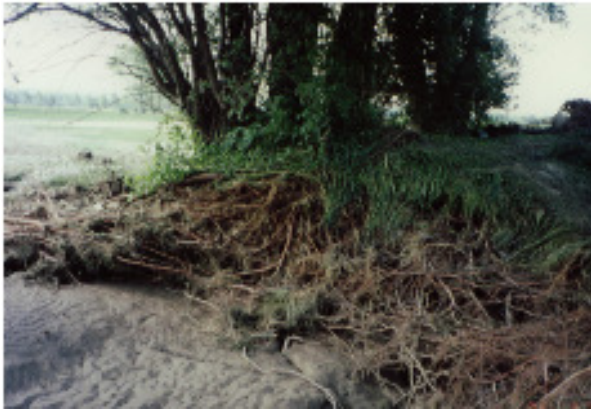
Breakage of the Ammer dike during the Whitsun flood in 1999 (Source: WWA Weilheim)

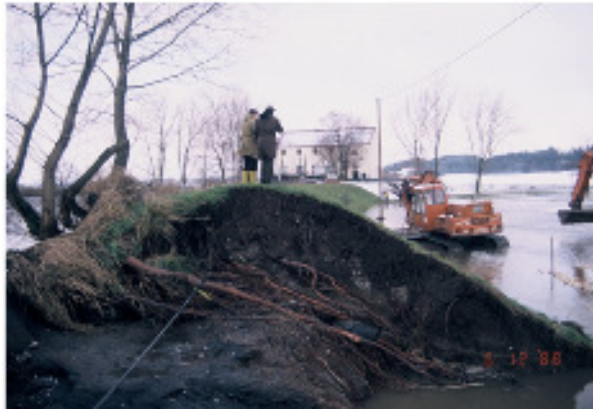
Breakage of the dike near Höselhurst on the Danube during flooding 1988 (Source: TU Munich)

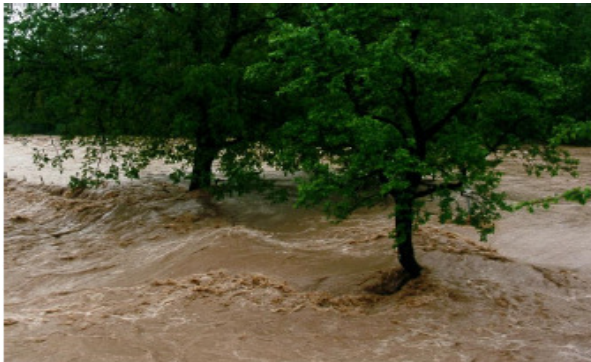
Breakage of Loisach dike in Bavaria during the Spring flood 1999 (Source: WWA Weilheim)

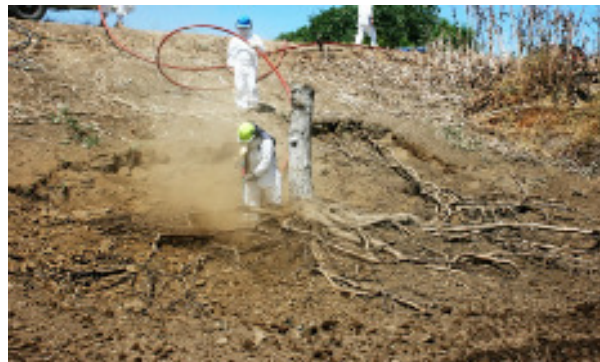
Rooting through embankment Vernalis, California, USA (Source: Berry and Chung, 2013)

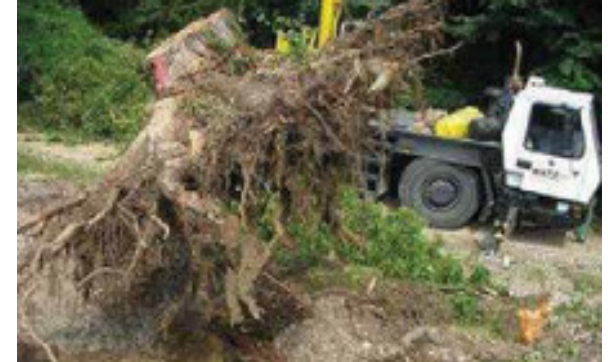
Flat Roots (Source: Int. Levee Handbook)

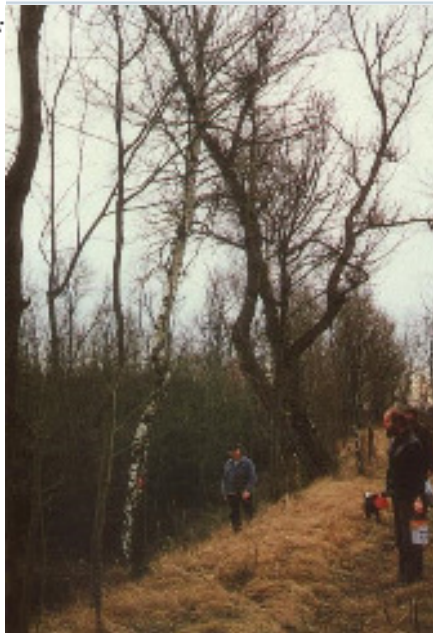
Roots of a poplar vertical through gravel layer and within topsoil layer (taken from Seethaler 1999)

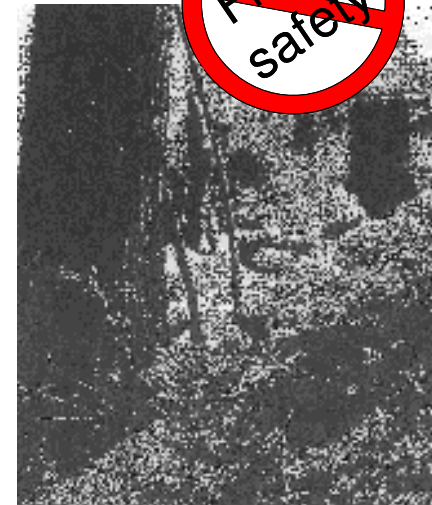
Maple tree with roots in topsoil and subsoil in a dyke at the river Danube (taken from LfW BY 1990)

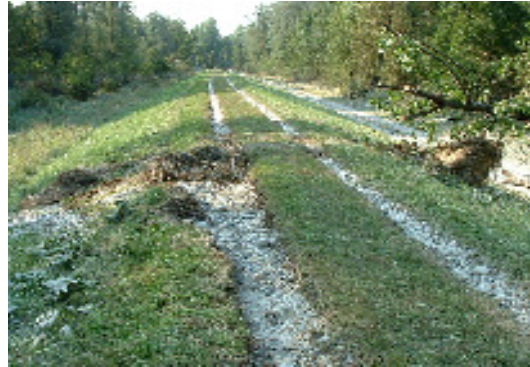
Erosion damages at dyke crest after windthrow lead to overtopping during flood incident 2002 at river Salzach (Source: LfW)

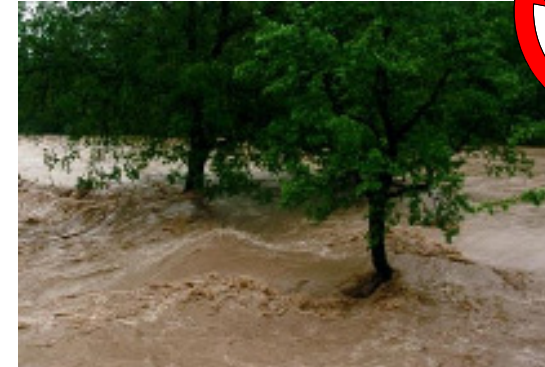
Overtopping of a dyke at the village Eschenlohe (river Loisach) during flood incident 1999 (Source: WWA Weilheim)

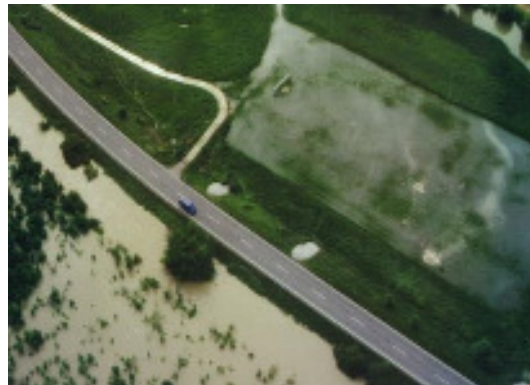
Erosion during the flood 1999 at the Danube in the area of Dünzing (Source: WWA Ingolstadt)

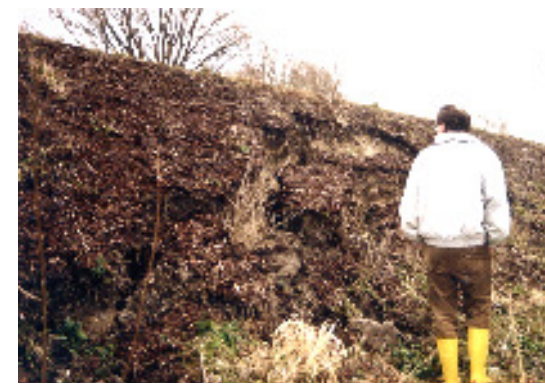
Sliding of top soil layer at the landside slope at river Danube 1988 (Source: WWA Deggendorf)

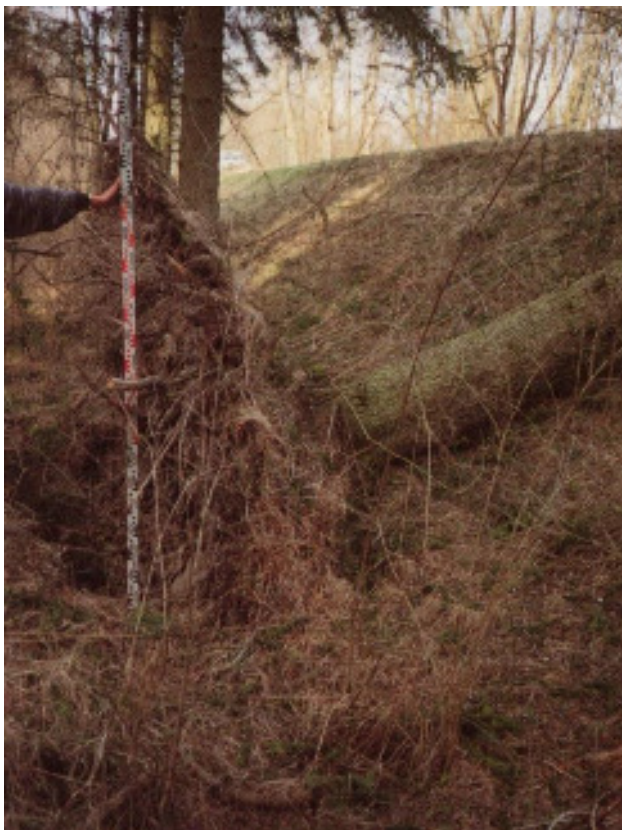
Thrown spruce at the landside dyke toe at the river Lech (taken from LfW BY 1990)

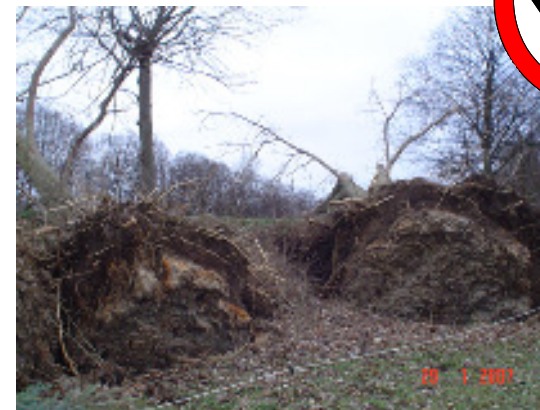
Windthrow at dikes at the Black Magpie during storm Kyrill 2007 (Source: LUA Brandenburg)

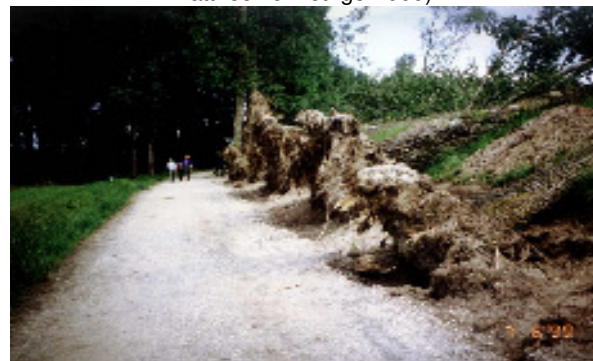
Thrown row of poplars at the landside dyke toe (Source: StMUVG)

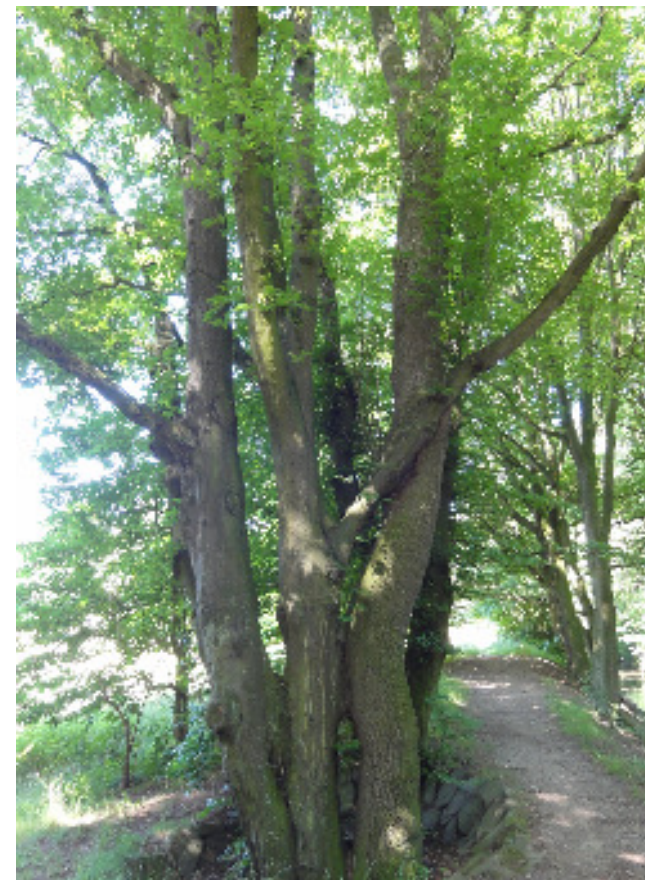
- Dike on Itter in Düsseldorf at the Rhine/Germany
  - No additional area available
  - **Statically effective sheet pile wall**
  - Area by area dike elevation
  - **Complete removal of woody plants** in dike protection zones I and II

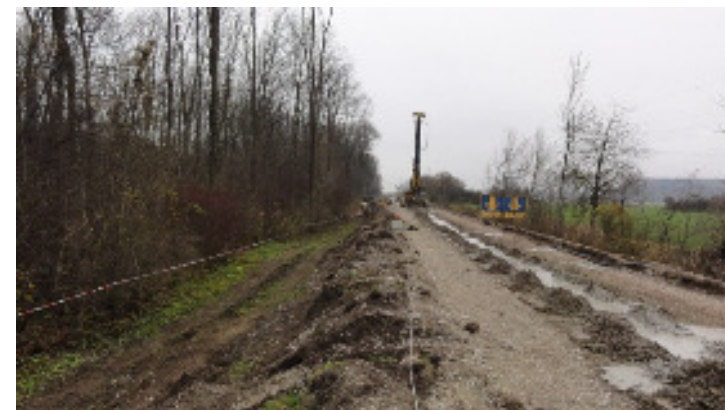
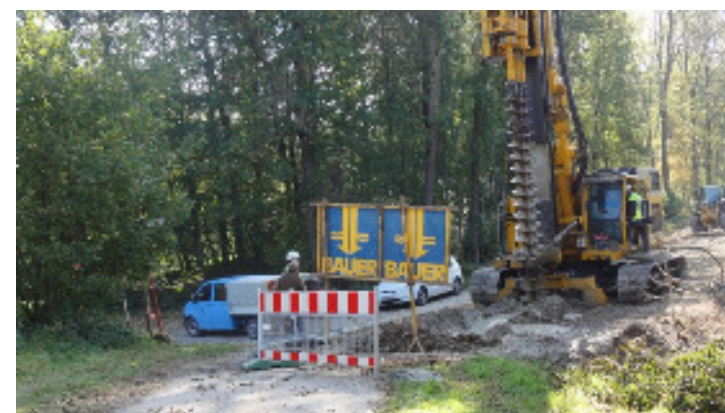
- Dike in Dietsheim/Balzheim Iller/Germany
  - **Statical mixed in place (earth concrete) wall**
  - Adjustment of the dike crest
  - Placement of a crest road
  - **Conservation of the existing tree vegetation**

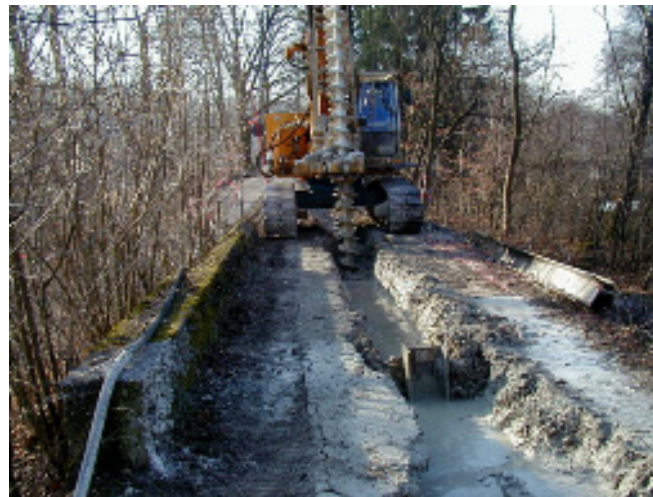
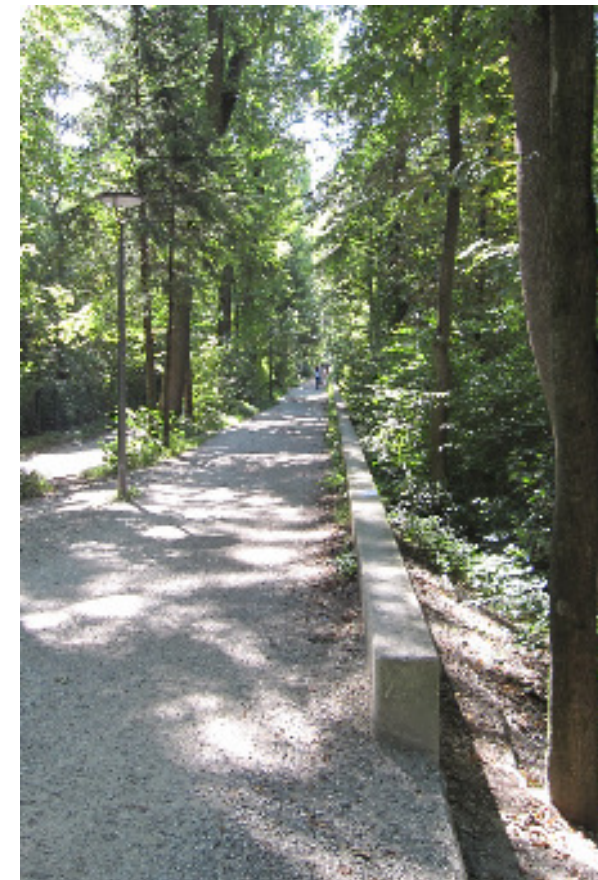
- Dike in Munich at the Isar/Bavaria/Germany
  - Minimal impact on the existing dike
  - **Static mixed in place (earth concrete) wall**
  - Dike heightening
  - **Conservation of existing tree vegetation**

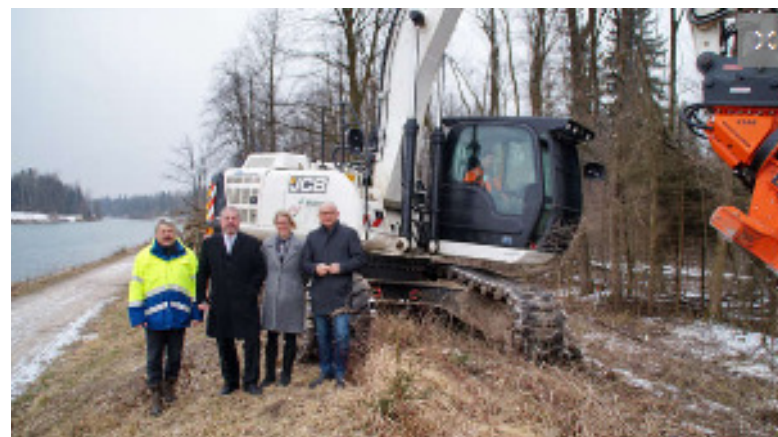
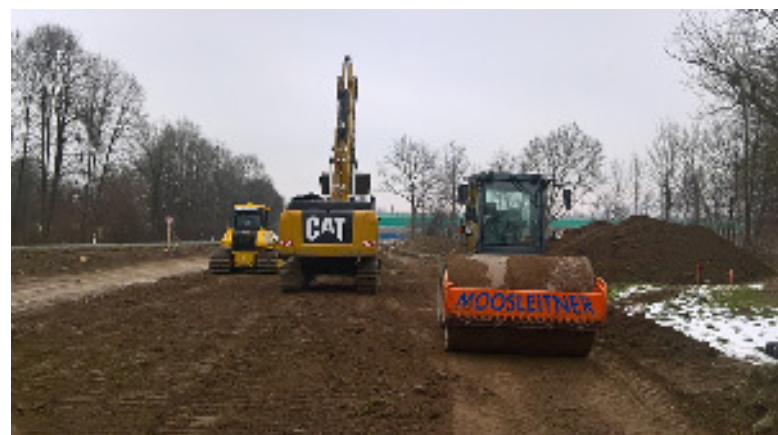
- Dike on the Saalach in Freilassing/Bavaria/Germany
    - **New construction and rehabilitation**
    - Minimization of the land use
    - Allowance of new trees up to the dike foot
    - **Static mixed in place (earth concrete) wall and steel sheet piles**
- **Effects on groundwater**
