The Rehabilitation of Levees with Large Trees by Equivalent Static Systems

R. Haselsteiner, D. Kerres

Bjoernsen Consulting Engineers, Koblenz, Germany

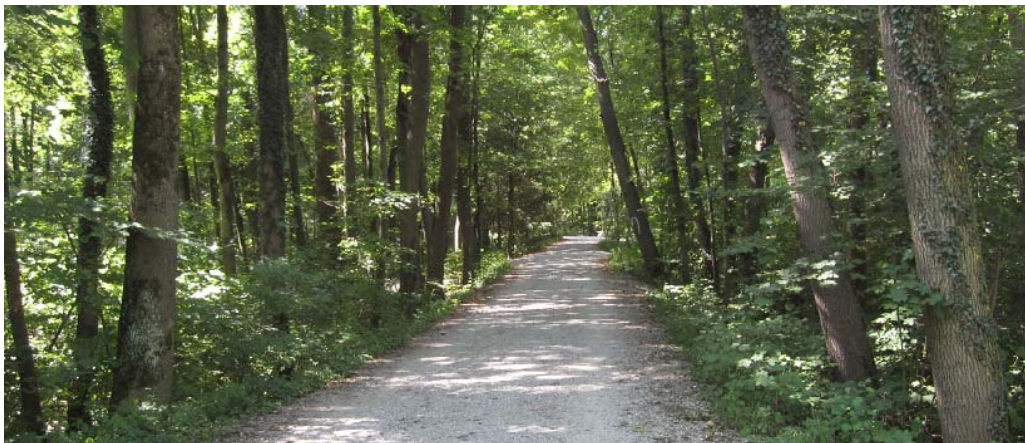
Figure 5. Forest-like woody vegetation on and nearby a levee at the River Isar within the city of Munich in Germany (Bavaria) (taken from Haselsteiner, 2019).

In Figure 6 a typical example of a levee is given. The levee is located in south of Germany within the city of Munich. The levee is on the right side of the River Isar and is close to the local zoo. The levee crest is used for the inhabitants for walking and sports. The vegetation is forest like. It is not visible that the way is also a crest road. The levee was rehabilitated by placing an equivalent static system into the dike body. The case study is explained later in the paper in chapter 4.

As aforementioned in Figure 5 a levee in Munich at the River Isar showed forest-like vegetation. In order to conserve the most of the existing vegetation the responsible authorities decided to use the soil mixing method with reinforcement bars. Where the levee needed to be heightened a cantilever wall was added (Figure 11).

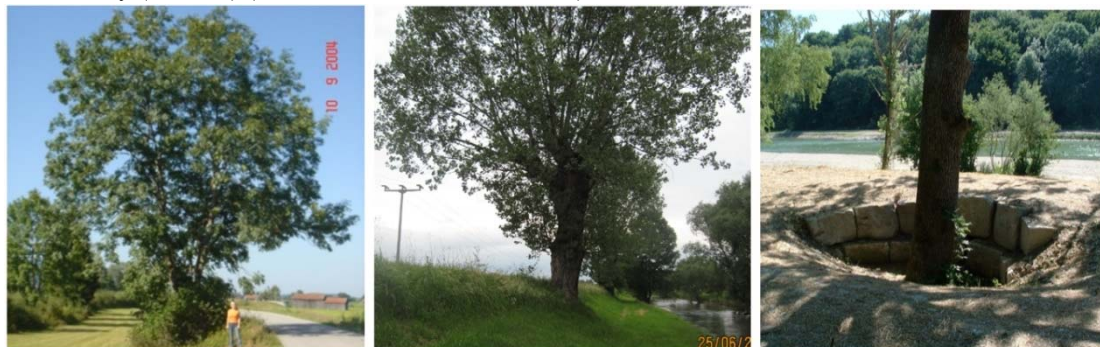
Figure 6. Single large trees on and close to levees at the River Loisach (Bavaria) (left), the River Gera (Thuringia) (middle) and the River Isar (Bavaria) (right) (taken from Haselsteiner, 2019).

Many examples of similar conditions are available throughout Germany (see Figure 6 and Figure 7). During storm events many tree failures are documented which have torn huge crater into the dike body (Figure 8). The simultaneous appearance of wind storms and flood events is unlikely to occur but cannot be excluded. In Germany beginning of the year 2018 medium floods occurred on the Rhine River and its tributaries which were accompanied by a major storm event which stroke large parts of France and West Germany.

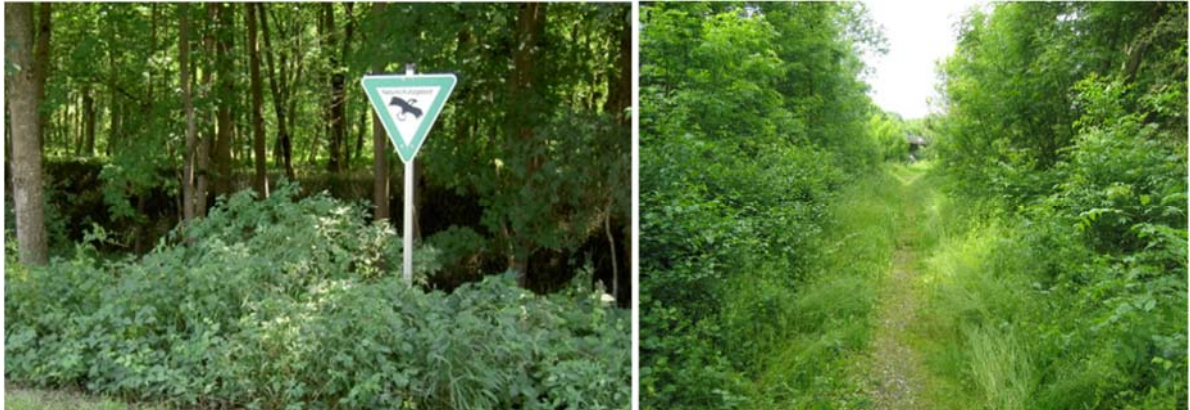
Figure 7. Forests developed around levees at the River Danube (left) and River Iler (right) in the south of Germany.

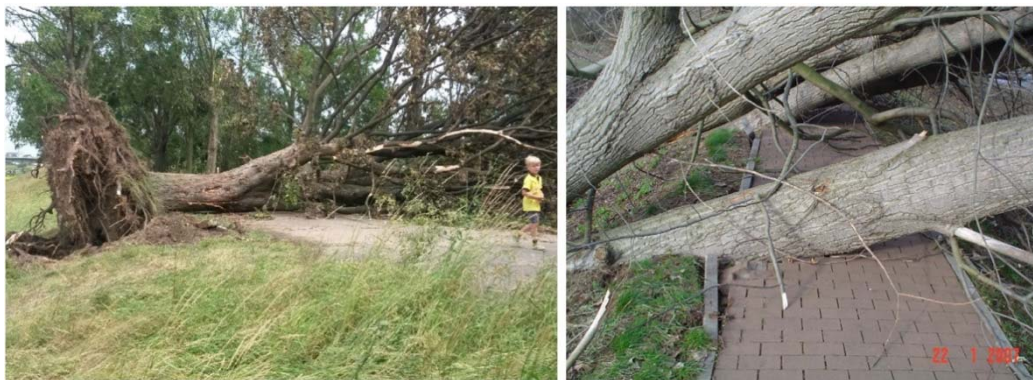
Figure 8. Tree failures at levees as a cause of strong storm events after a storm 2014 (left) (Source: SEB Düsseldorf) and 2007 (right) (Source: LUA Brandenburg).

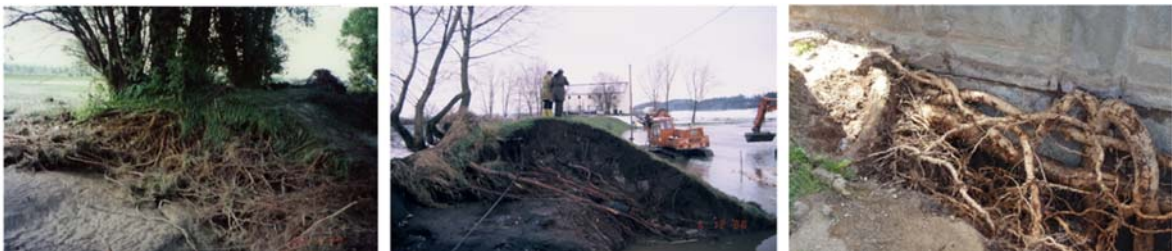
Figure 9. Rooted levees at the River Ammer (left) (Source: WWA Weilheim) and River Danube (middle) (Source: LfW BY) and excavated roots of a poplar at a flood protection wall in Düsseldorf (right)

For levees not only the tree itself and a failure of it is a major risk but the effect on the seepage conditions. The roots may completely penetrate a levee body which may lead to strong seepage flow accompanied by suffusion and erosion processes which again may lead to a total levee failure. Case studies report quite abnormal root growth and development which may differ to the typical root characteristics fundamentally (see LfW BY, 1990; Winski, 2004; Haselsteiner & Strobl, 2005). Selected examples are presented in Figure 9.

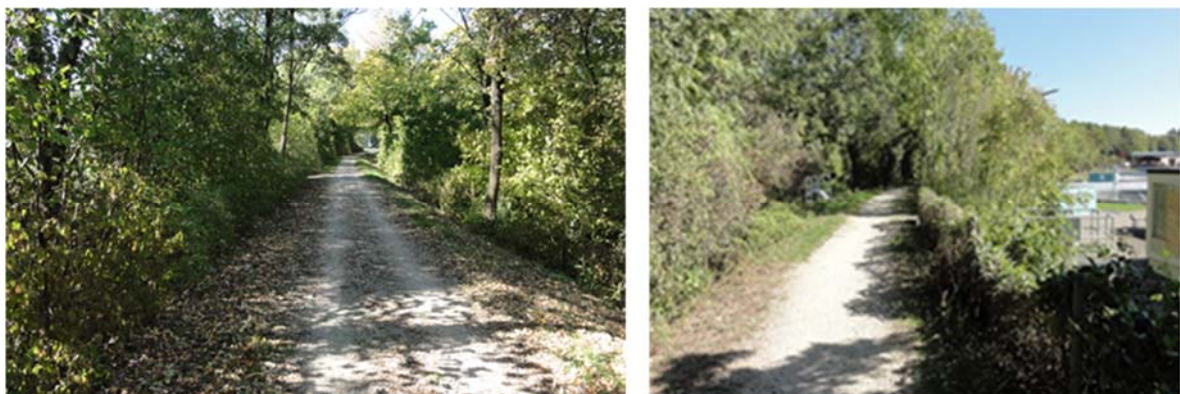
Figure 13. Existing levees along the Neckar River at the city of Nuertingen with large trees on both slopes (taken from Kerres & Haselsteiner, 2018).

In Nuertingen at the River Neckar close to Stuttgart flood protection measures are under design. The existing levees need rehabilitation due to stability concerns, height deficits and the occurrence of large trees (Figure 13). In the Neckar valley the available areas for compensation are very limited so that the owner put a high priority on the avoidance of environmental impact. Thus, the present design includes steel sheet piles and soil mixing walls in order to conserve existing woody vegetation as much as possible. Further, the steel sheet piles shall be hydraulically pressed so that no heavy equipment is required and the levee crest need not to be widened to approximately five meters in order to enable the access for heavy machinery. For this approach the owner accepts additional costs since the levees themselves show a height of maximum three to four meters.
