**INTERNATIONAL SYMPOSIUM ON
DAMS IN A GLOBAL ENVIRONMENTAL CHALLENGES**
Bali, Indonesia, June 1ST – 6TH, 2014

Design and Construction of the Dam Sealing Structures of Arkun CFSGD

Arkun Concrete Face Sand-Gravel Fill Dam (CFSGD) is one of largest sand-gravel fill dams of the world. The dam is founded on a deep alluvium layer sealed by a deep cut-off wall. The partly jointed rock foundation was treated by a classical grout curtain. The dam shows a concrete face slab for which a special joint design was developed. The connection of cut-off wall and surface slab is formed by a articulated horizontal plinth.

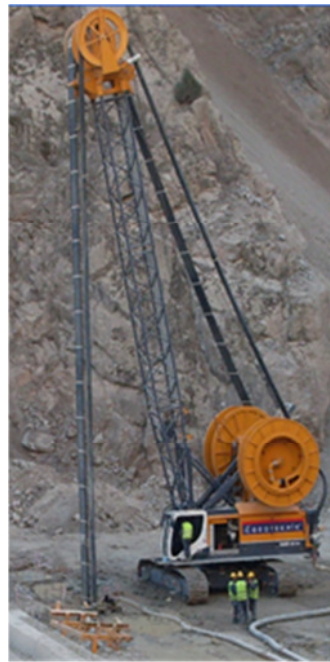
Figure 3. Cut off wall cutter machine

Due to the blocky characteristics of the alluvium the works of the cutter were the hardest part since the cutter got stuck several times and the wearing of the machine parts was considerable. Figure 3 shows the cutter machine while drilling at the toe plinth line.

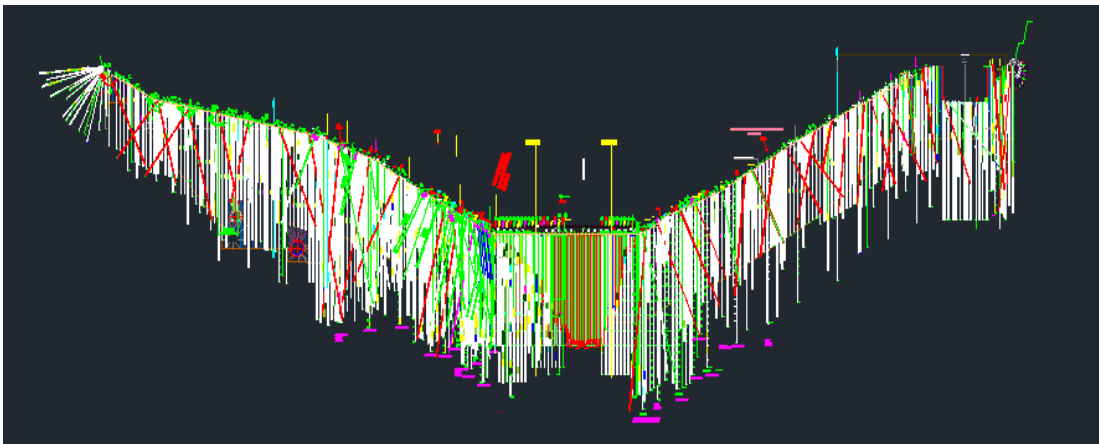
Figure 5. General view of grout curtain (from upstream to downstream)

The number and distance of grouting drillings was adjusted. Figure 5 shows general layout of the final grout curtain design.

The left bank is more geologically more difficult in terms of grouting compared to the right bank. This fact is also stated in the development of the control Lugeon tests and values carried out regularly after a grouting sequence was completed. Figure 5 shows clearly the success of the grout works at the left bank.
